Southland Drainage Study Volume II of II

**Rochester
Johnson Yards
Red Budd
Southland
Rosita**

**Prepared For:
City of Memphis
Division of Engineering**

**Prepared By:
Smith Seckman Reid, Inc.
Powers Hill Design, LLC
Geodesy Professional Services, LLC**

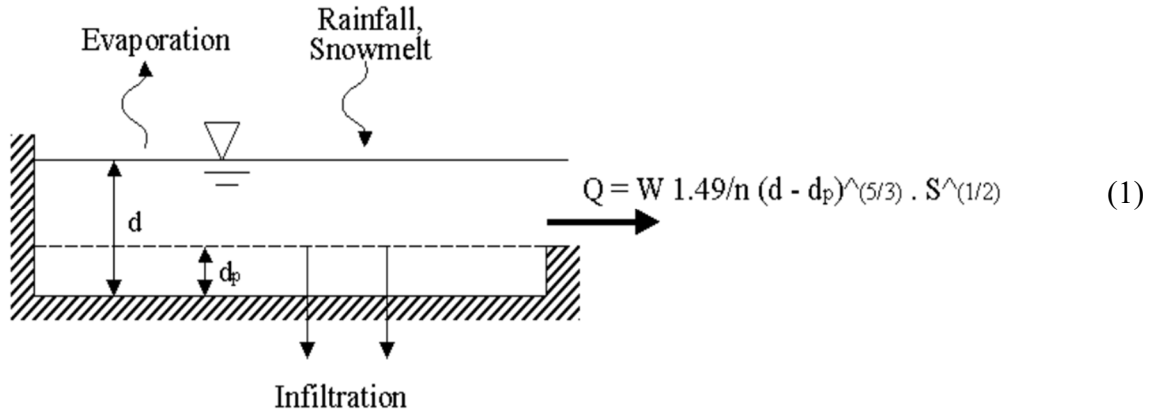
Equation (1) and the schematic diagram and below display how the EPA SWMM Non-linear Reservoir Runoff Model functions:

where:

- Q is surface runoff flow rate
- W is the subbasin width
- n is Manning's roughness coefficient
- d is the depth of water
- d_p is the maximum depression storage depth, and
- S is slope

The surface runoff calculation methodology used in the model was the EPA SWMM Non-linear Reservoir method. This calculation method was established by coupling the continuity equation with Manning's equation. Each subcatchment is treated as a "reservoir" with a storage capacity equal to the maximum depression storage (d_p), which is the maximum surface storage provided by ponding, surface wetting, and rainfall interception. Inflow enters the "reservoir" from precipitation and the upstream subcatchments, and it exits the "reservoir" through infiltration, evaporation, and surface runoff (Q). Evaporation wasn't accounted for in our model, and soil infiltration was estimated using the Green-Ampt method. Surface runoff (Q) only occurs when the depth of water (d) in the subcatchment "reservoir" exceeds the maximum depression storage (d_p), in which case the outflow is given by Manning's Equation. The depth of water over the subcatchment "reservoir" (d) was continuously updated at each modeled time step through numerically solving a water balance equation over the subcatchment.
